Feedback

Canadian Aviation Service Difficulty Reports

TP 6980E (03/2013)

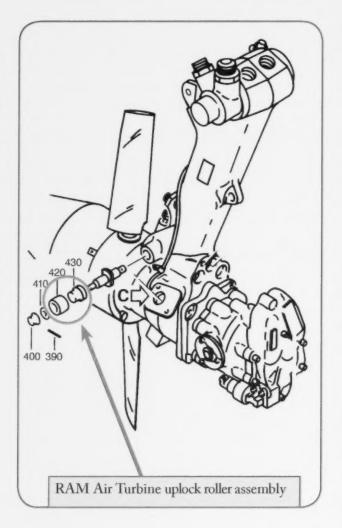
Seized Ram Air Turbine Uplock Roller

Maintenance was performing an operational task of the ram air turbine (RAT) uplock mechanism during an A-06 check when it was discovered that the RAT failed to deploy from both the captains and first officers release handle.

After the investigation it was found that the uplock roller on the RAT was seized.

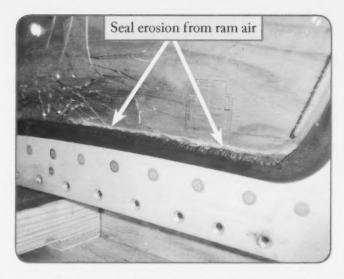
Windshield Failure

On descent into destination, the captain's windshield shattered. The flight continued to destination and landed safely. The aeroplane was removed from service for maintenance to replace the left-hand windshield.

It was noted by the operator that there was erosion of the outboard upper rubber seal or "moisture seal" which may have allowed moisture to permeate and cause the outer pane of this windshield to fail.

All operational tests were carried out making the aeroplane serviceable.

As stated in the applicable Aircraft Maintenance Manual (AMM) 56-11-01, "inspect the outboard moisture seal for cracks or erosion... and repair if necessary..."

Transport Canada Civil Aviation is advising all owners, operators and maintainers of the aforementioned AMM reference for various inspections and repairs that are available to prevent such occurrences as seen in this article.

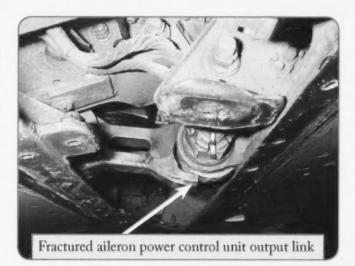
Fractured Aileron Output Link

During a scheduled heavy maintenance inspection for a functional check of the two aileron power control units (PCU) at each aileron panel, the aircraft maintenance engineer (AME) found one of the two PCU output links on the right-hand aileron panel fractured and separated.

The maintenance program of this aeroplane has been developed to capture failures such as this in order to prevent a complete failure of the flight control system.

The output link was replaced and the system was brought back to a serviceable condition.

Transport Canada Civil Aviation is advising all owners, operators and maintainers of this potential dormant failure and to be sensitive to flight crew snags related to this system.

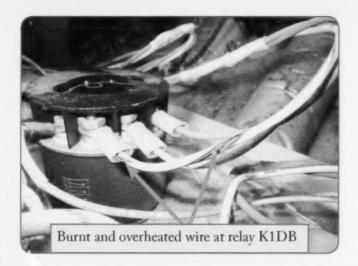
Wiring Overheat Damage

While investigating an unrelated defect on the aeroplane, the Aircraft Maintenance Engineer discovered burnt wiring related to the 3A hydraulic pump power relay K1DB circuit. Wire # DB18B12WHT was burnt approximately 20.32 cm (8 inches) leading up to the power relay.

It is suspected that improper wire terminal crimping caused the wire overheat condition.

The affected wires were replaced as defined in the Electrical Standard Practices Manual and the aeroplane was returned to service.

Transport Canada Civil Aviation (TCCA) is advising all aeroplane maintainers of the importance to diligently follow all manufacturer manual instructions when replacing aeroplane parts or performing repairs.

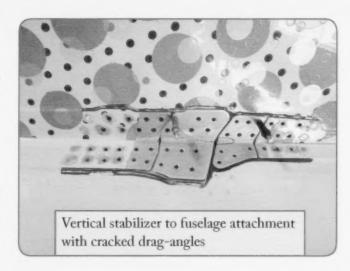
Cracked Drag-Angle

During a visit to a painting facility, cracks were found on the left-hand vertical stabilizer to fuselage attachment drag angles in both forward and aft positions.

Transport Canada Civil Aviation (TCCA) is presently working with Bombardier engineering to better define this drag-angle failure characteristic and its implications.

The aeroplane was repaired in accordance with a Bombardier repair engineering order (REO) REO 690-55-31-010 and was later made serviceable.

TCCA is advising all CRJ700/900 owners and operators of this possible condition.

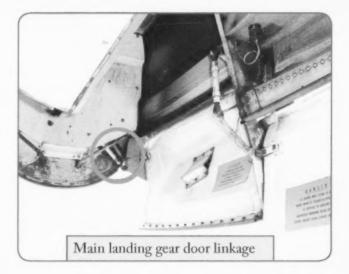
SDR # 20120418003

Main Gear Door Linkage

The crew reported loss of #2 hydraulic system pressure with rudder caution light and left hand (L/H) main landing gear unsafe light indications. The crew then cycled the landing gear to confirm that a problem existed and then returned to a nearby airfield for an uneventful landing.

Maintenance crew found that the outboard L/H main gear door pushrod (P/N 83231014-003) and corresponding spring assembly (P/N 83231020-003) failed. It appears that when the landing gear was deployed, an adjacent hydraulic line was severed resulting in rapid loss of fluid and loss of #2 hydraulic system.

It is recommended that maintenance personnel closely inspect the landing gear doors and linkages to prevent future occurrences of this nature.

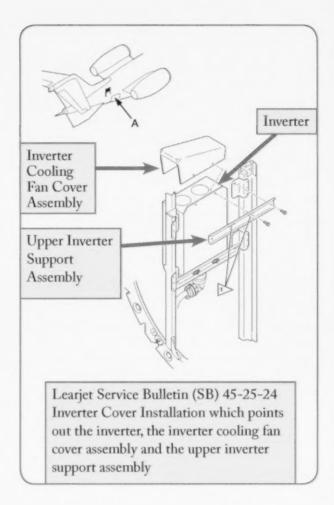
Cabin Inverter Unit Failure

The right-hand non essential bus switch light illuminated as the crew lined up for take-off. They returned to the flight support ramp area and shut down the aeroplane. A very strong electrical burning odor was noted as maintenance disconnected the batteries in the aft equipment bay.

Maintenance conducted a complete inspection and noted that the root cause of the burning order was an unserviceable inverter.

It has been found that condensation in the tailcone aft equipment bay may drip onto the inverter causing it to fail. Learjet Service Bulletin SB 45-25-24 will reduce this possibility of moisture entering the inverter and will direct the warm airflow from the inverter cooling fan away from the wiring that is routed above the inverter.

Maintenance proceeded to replace the failed inverter, the upper main battery, the remote control circuit breaker and the right-hand non essential bus 80 amp fuse.

The complete system function tested good with no burning smell or overheat conditions and the aeroplane was returned to service.

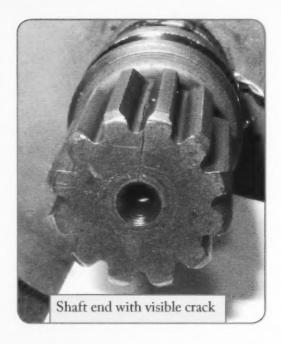
SDR # 20120502009

Cracked Starter - Generator Spline

The starter-generator was removed for overhaul with 1786 hours total time airframe. During overhaul, a magnetic particle inspection detected a crack radially and longitudinally in the drive spline that engages with the engine.

Considering the date of manufacture and the total number of hours on the airframe, it is possible that there may have been a vibration or installation issue with this unit. It is fortunate that the inspection cycle for this component detected the fault before total failure occurred.

The starter-generator was manufactured in March 2006. The cracked shaft was replaced with a new one.

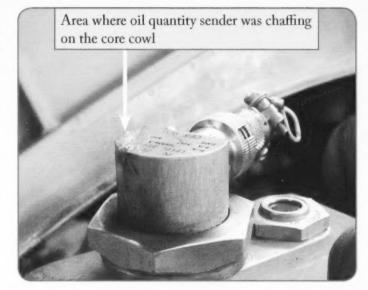
Oil Transmitter Interference Fit With Core Cowl

During a scheduled #1 engine change, the upper core cowl was found with a 2.54 cm (1 inch) puncture in it. An investigation revealed that the core cowl was in contact with the top of the oil tank level sensor on the removed engine. A new core cowl was installed on the new engine.

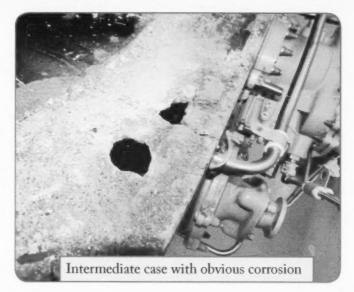
Intermediate Case Corrosion

The engine was returned to Rolls Royce Canada for midlife inspection. While dissembling the engine, during the outlet guide vane ring removal, it was noted that the external intermediate casing wall had excessive corrosion that had created a hole through the casing wall and generated a 25.4 cm (10 inch) crack. The engine had also excessive visible corrosion to other areas of the case and inside the low pressure compressor.

Rolls Royce has issued Service Bulletin 72–1399 that deals with corrosion concerns on the TAY engine as well as a safety alert on this event. Operators are encouraged to contact Rolls Royce through their web site or field service representatives for additional information.

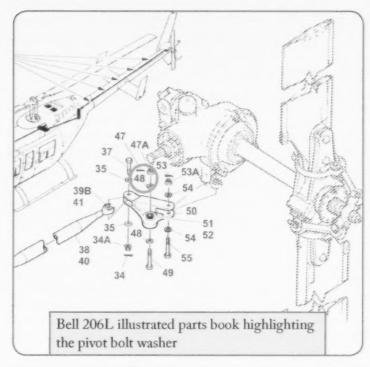
Tail Rotor Bellcrank Wear

During a 100-hour periodic inspection, it was noticed that the tail rotor bellcrank at the end of the tail boom which actuates the pitch change mechanism, had a large amount of axial play causing the bellcrank to "float" within its attachment. Upon removal of the bellcrank for further investigation, it was discovered that the pivot bolt (NAS6604D23) was very loose though the nut was properly cotter pinned. Also once the bellcrank was removed, it was discovered that the washer (AN960-416) under the nut had excessive wear (probably due to the low torque condition).

The person responsible for maintenance surmises that the excessive wear of the washer was due to the low torque value of the nut causing the clamping of the bellcrank to be loose inside its support bracket. It should be noted that the location of the bellcrank is very hard to access and the torquing procedure is almost impossible to comply with using a standard torque wrench. The attaching hardware has to be tightened by "feel". Once the assembly was properly installed with new hardware and torqued to approximately 40 in/lbs as called out for, the installation was secure with no discernible axial or radial play.

The bellcrank assembly was thoroughly visually inspected as well as the bushings on the attachment bracket in the tail boom. All items were found satisfactory. However upon reinstallation using new hardware, a discrepancy was noted between the illustrated parts book (IPB) and the installation instructions in the maintenance manual.

Bell helicopter technical publications and product support engineering was notified of the discrepancy. A correction will be made in the next revision of the IPB and the installation instructions in the maintenance manual.

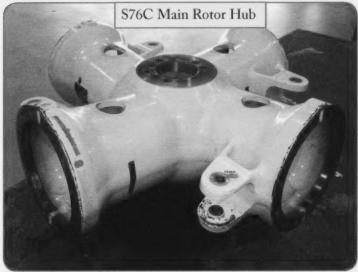
Main Rotor Hub Cracked

During the three year hub visual inspection, a crack was noticed on a damper lug. An eddy current inspection was used to confirm the crack. Main rotor hub replaced.
